### **Clinical Image**

## A case of central venous catheter rupture due to Pinch-off syndrome

**Keywords:** Central venous port; Chemotherapy; Left subclavian vein; Catheter fracture; Catheter migration; Pinch-off syndrome.

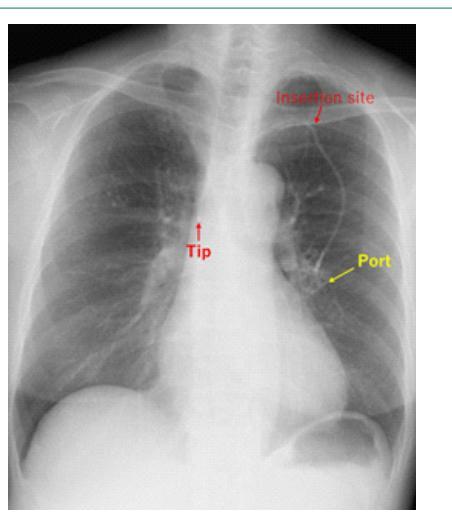
**Figure 1:** Catheter before rupture. This catheter placement is within the midclavicular line.

sertion [1]. Herein, rupture occurred at 10 months, likely due to catheter placement within the midclavicular line and increased patient activity.

Ultrasound-guided insertion and placement lateral to the midclavicular line are advised to minimize compression risk. Embolized catheter fragments can lead to severe complications [2]. Signs of pinch-off include impaired blood return, slow infusion, injection resistance, and pain. Hinke et al.'s grading system supports regular imaging for catheter deformation [3]. With the pinch-off phenomenon in mind, there is no recommendation on the follow-up examination frequency. If pinch-off occurs, in principle, the catheter needs to be removed. However, CV port placement and management guidelines show catheter retention not causing clinical problems when it cannot be removed even with the use of a guidewire, and from a clinical risk-benefit perspective, leaving the catheter in situ is an acceptable option. In case of infection, catheter removal is essential, and in such cases, catheter removal by surgical vascular resection or vascular incision should be considered [2].

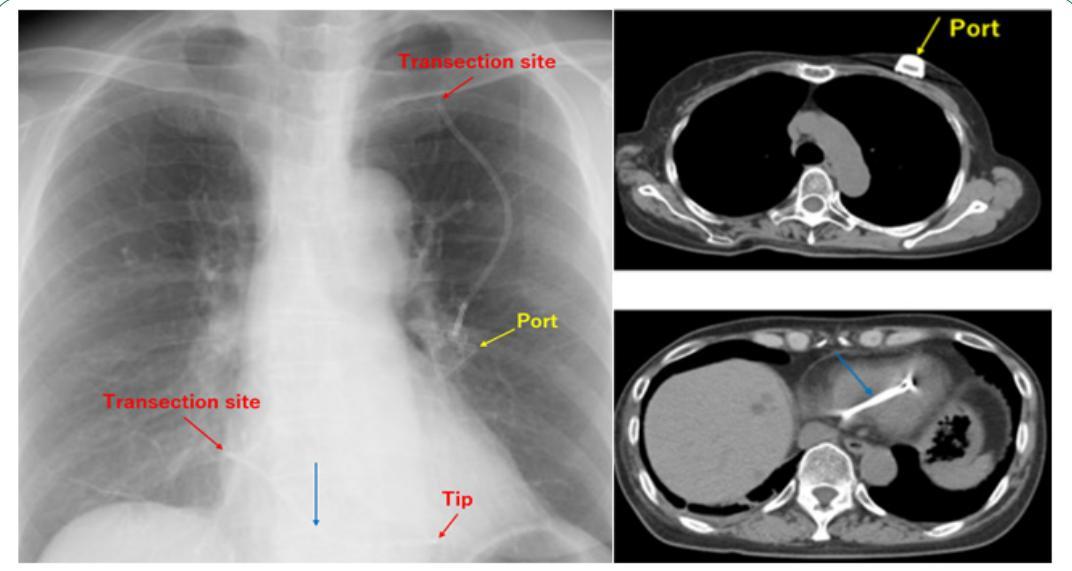
**Figure 2:** Lateral chest radiograph showing a fractured catheter segment in the right ventricle (left) and contrast-enhanced computed tomography scan (transverse view) demonstrating the catheter port positioned within the left subclavian vein (right).

A 68-year-old woman with lymphoma underwent central venous (CV) port placement via the left subclavian vein for chemotherapy administration. However she achieved remission, the port was retained due to the disease recurrence risk. After 10 months post-insertion, contrast-enhanced computed tomography (CT) revealed catheter fracture with distal fragment migration into the right ventricle (Figure 1). She remained asymptomatic, and no immediate action was taken. One month later, retrospective review identified catheter fracture, leading to vascular surgery referral.

A 6-Fr sheath via the femoral vein enabled pigtail-assisted catheter fragment retrieval from the right ventricle. She recovered uneventfully and was discharged on day 3. Pinch-off syndrome, a known complication of subclavian CV catheterization, is caused by compression between the clavicle and first rib, leading to catheter deformation or rupture. The incidence ranges from 0.1% to 1.0%, typically occurring 3.5 years post-in-
