Clinical Image

Diagnostic challenges in orthopedic imaging: Uncommon periprosthetic fracture of the left hip***Corresponding Author: Rahul Singh**

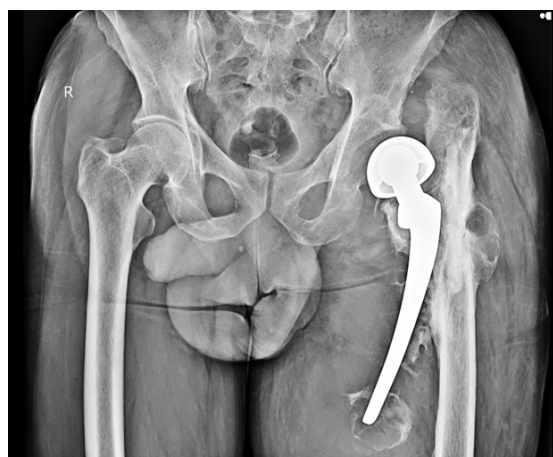
**Figure 1:** Clinical image.

A 55-year-old male presented with a displaced periprosthetic fracture. He was operated on 12-years ago with cemented bipolar hemiarthroplasty for the neck-femur fracture of the left hip. Radiographic evaluation revealed a displaced Vancouver B3 periprosthetic fracture with severe osteopenia and pronounced stem loosening, and the distal part of the stem displaced medially with calcifications around the tip of the stem.

Management: Given the patient's age, fracture pattern, bone quality, and construct loosening, infection was ruled out, and the decision was made to proceed with the removal of the bipolar prosthesis. The patient underwent a removal of the prosthesis, and postoperatively, the patient was made to bear weight as tolerated and is awaiting a staged revision arthroplasty.
